Title: Weathertightness and impact testing of Scalamid panels for

Architectural Facades

Report No: N950-21-18110

Issue date: 8 June 2021

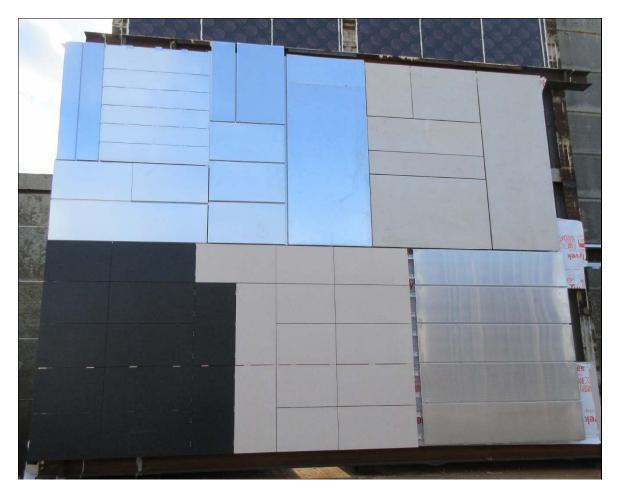
PHOTO 7569

The sample was as shown in the top right-hand side of photo below and the drawings included as an appendix to this report.

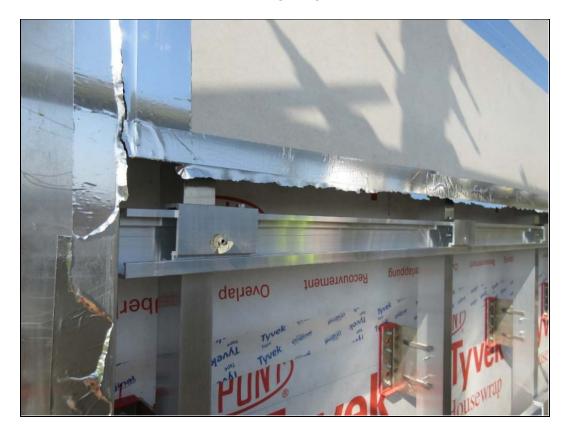
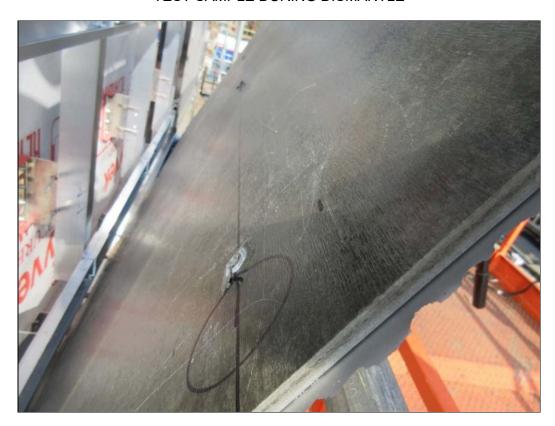
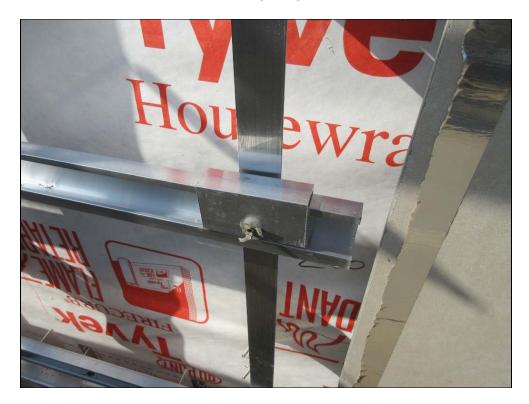
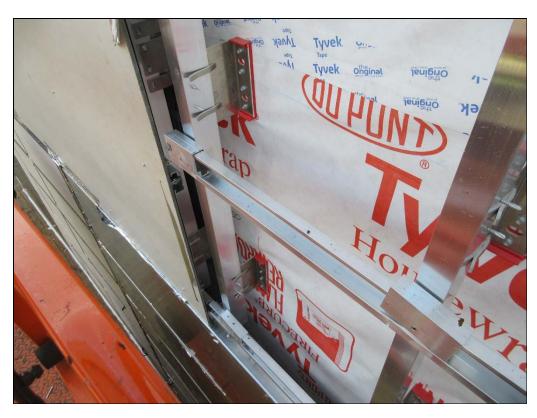
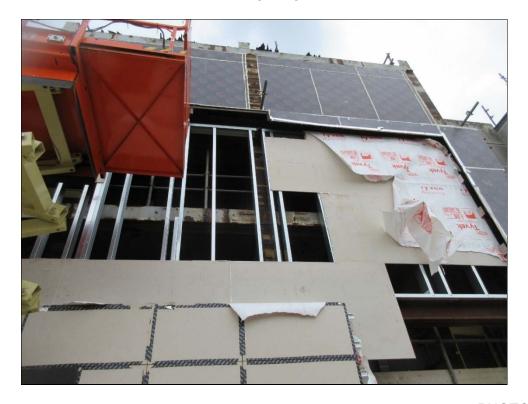
During the dismantling of the sample no water penetration or discrepancies from the drawings were found.

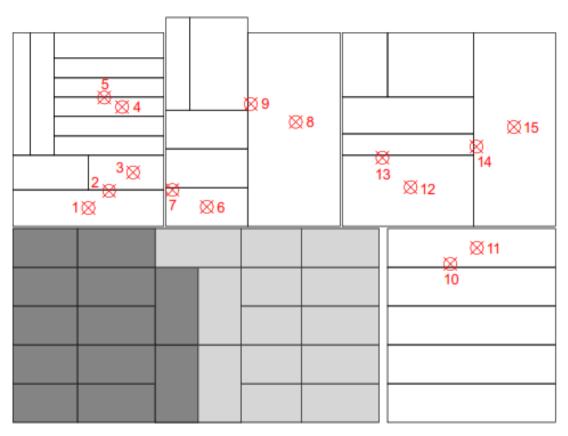
FIGURE 2

The deflections measured during the wind resistance test, at the positions shown in Figure 2, are shown in Tables 5 and 6.

No damage to the test sample was observed.

No damage to the sample was observed.

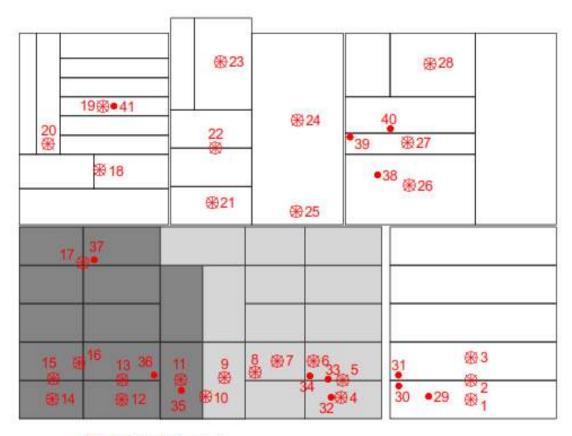
FIGURE 3

Location	Impact energy (Nm)	Observations	Classification
26	120 x 3	No damage observed	Class 1
	350	No damage observed	Negligible risk
	500	No damage observed	Negligible risk
27	120 x 3	No damage observed	Class 1
	350	No damage observed	Negligible risk
	500	No damage observed	Negligible risk
28	120 x 3	No damage observed	Class 1
	350	No damage observed	Negligible risk
	500	Horizontal crack in panel	Low risk

Location	Impact energy (Nm)	Observations	Classification
38	3	No damage observed	Class 1 / Negligible risk
	6	No damage observed	Class 1
	10	Minor indent	Class 1 / Negligible risk
39	3	No damage observed	Class 1 / Negligible risk
	6	No damage observed	Class 1
	10	Corner crack	Class 2/ Negligible risk
40	3	No damage observed	Class 1 / Negligible risk
	6	No damage observed	Class 1
	10	No damage observed	Class 1 / Negligible risk

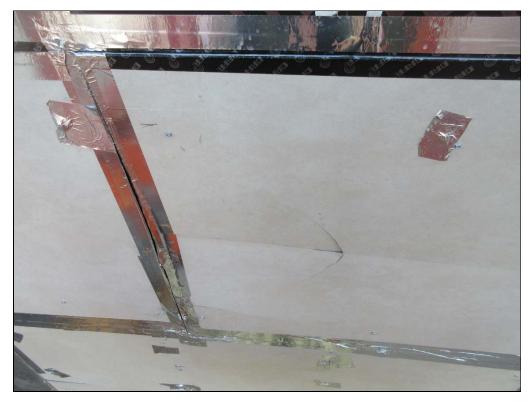
PHOTO 7768

SOFT BODY IMPACT
